# **3-YEAR ASBESTOS RE-INSPECTION REPORT**

## **FRANCES WILLARD ELEMENTARY SCHOOL SCRANTON, PA**

**SCRANTON SCHOOL DISTRICT  
425 North Washington Avenue  
Scranton, Pa. 18505**

PROJECT: #SSD.19\_751

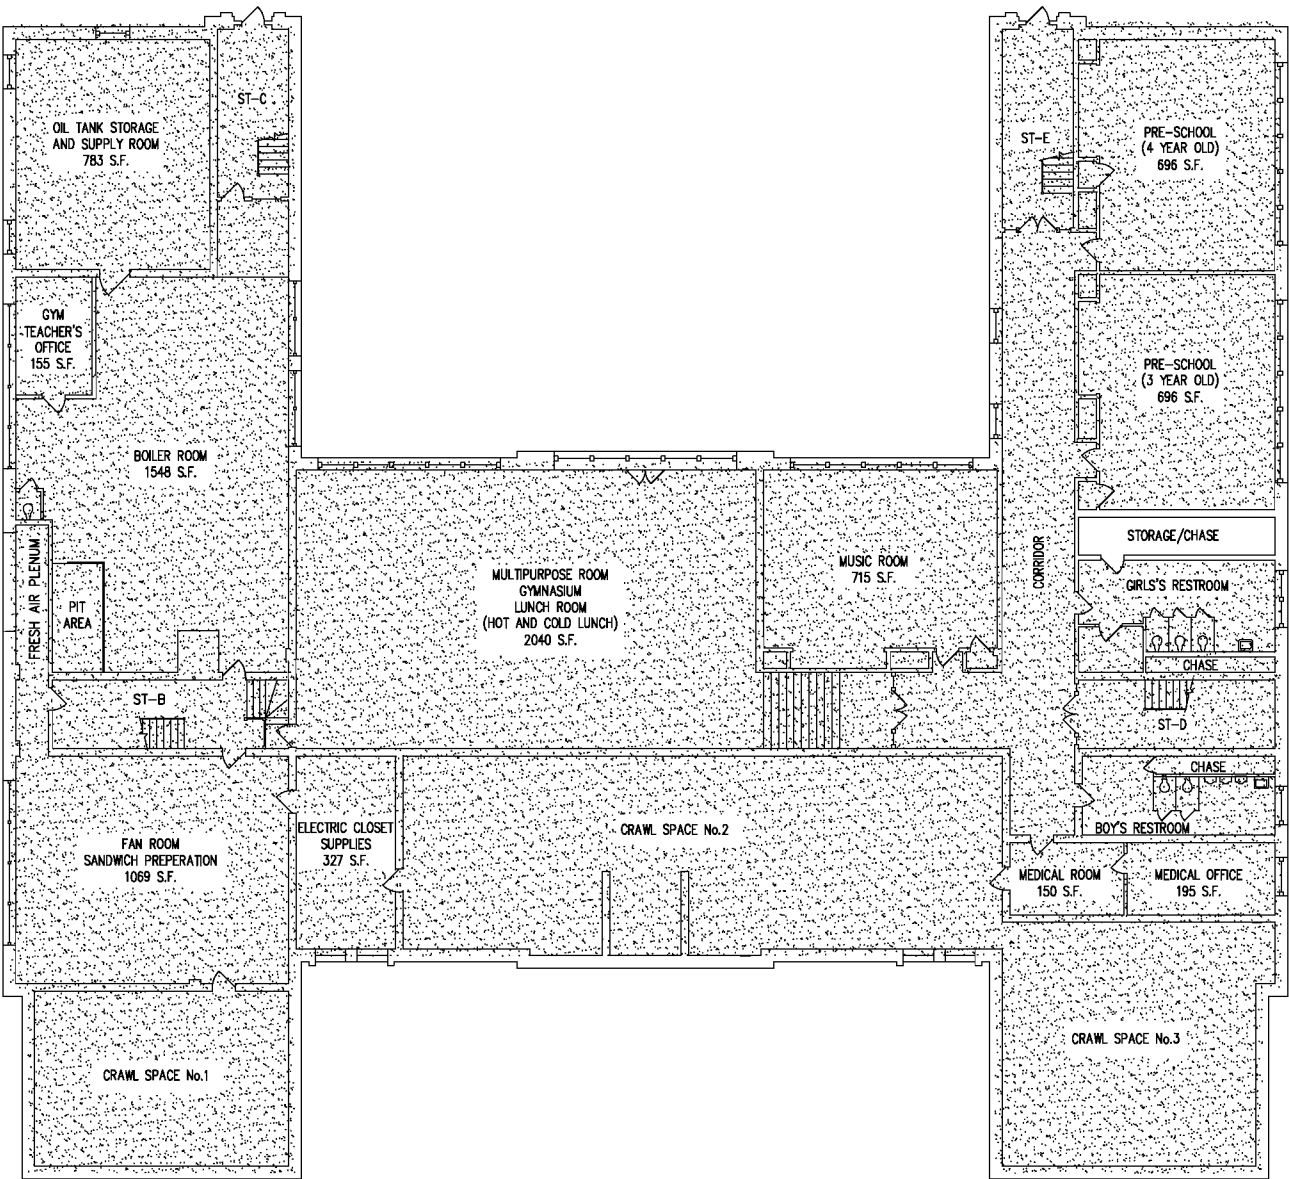
BASEMENT PLAN  
NOT TO SCALE

ASSUMED ASBESTOS CONTAINING SURFACING MATERIALS:

1. CHALKBOARD AND WALLBOARD MASTIC

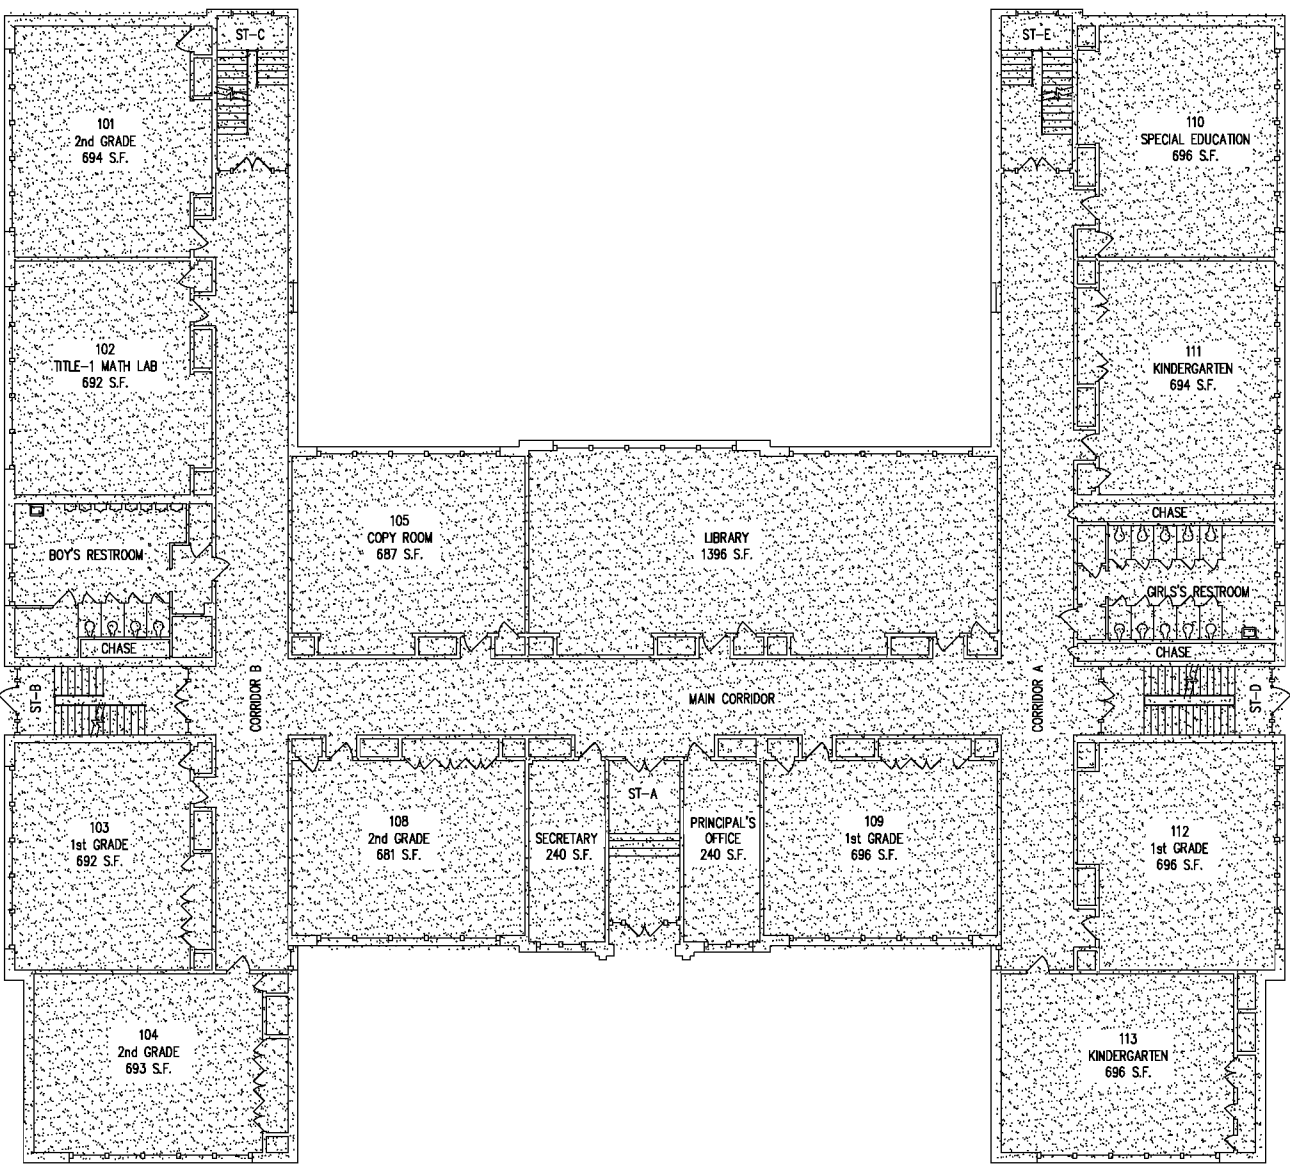
1ST FLOOR PLAN  
NOT TO SCALE

ASSUMED ASBESTOS CONTAINING SURFACING MATERIALS:

1. CHALKBOARD AND WALLBOARD MASTIC

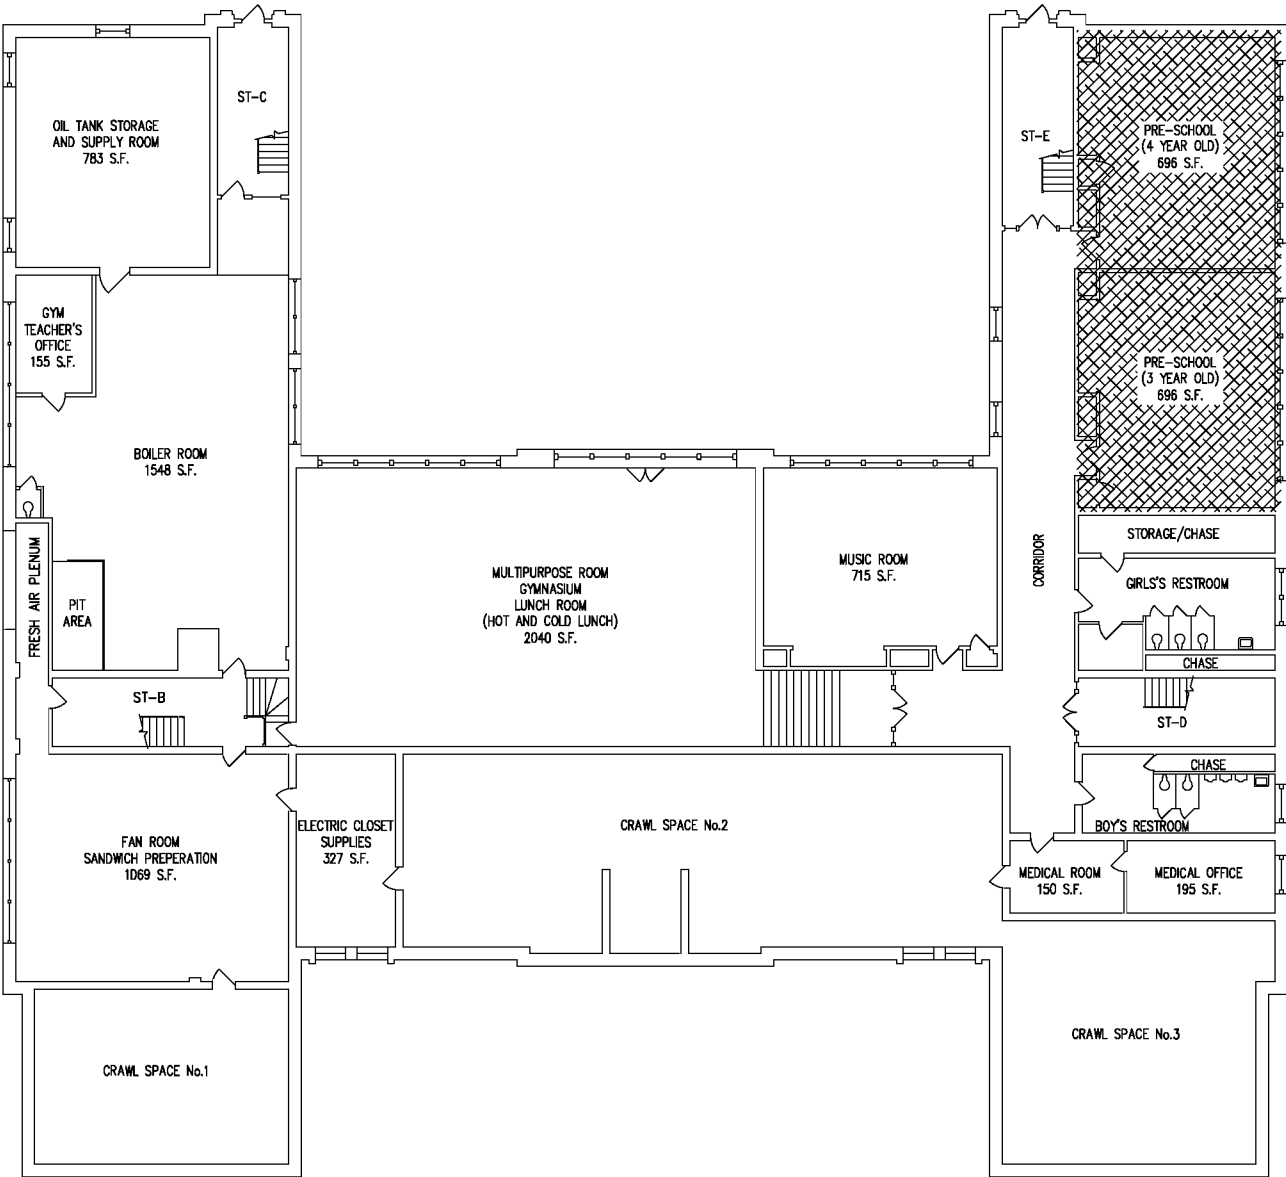
**BASEMENT PLAN**  
NOT TO SCALE

ASSUMED ASBESTOS CONTAINING MISCELLANEOUS MATERIALS:

1. DUCTWORK FLEX CONNECTIONS
2. EXTERIOR DOOR CAULKING

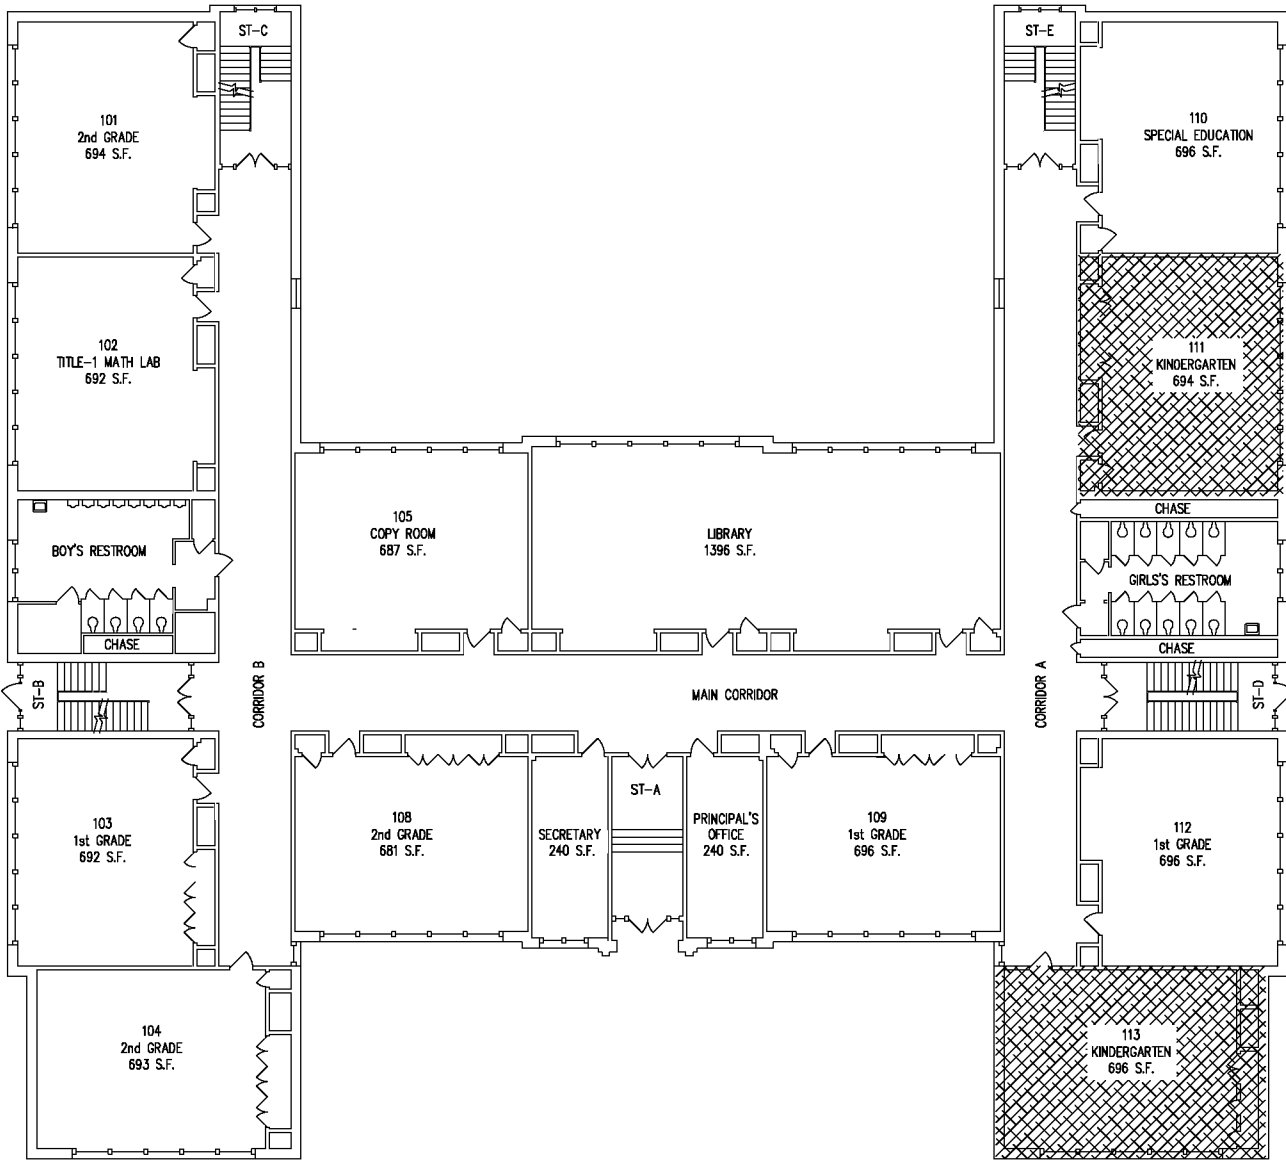
**1ST FLOOR PLAN**  
NOT TO SCALE

ASSUMED ASBESTOS CONTAINING MISCELLANEOUS MATERIALS:

1. DUCTWORK FLEX CONNECTIONS
2. EXTERIOR DOOR CAULKING

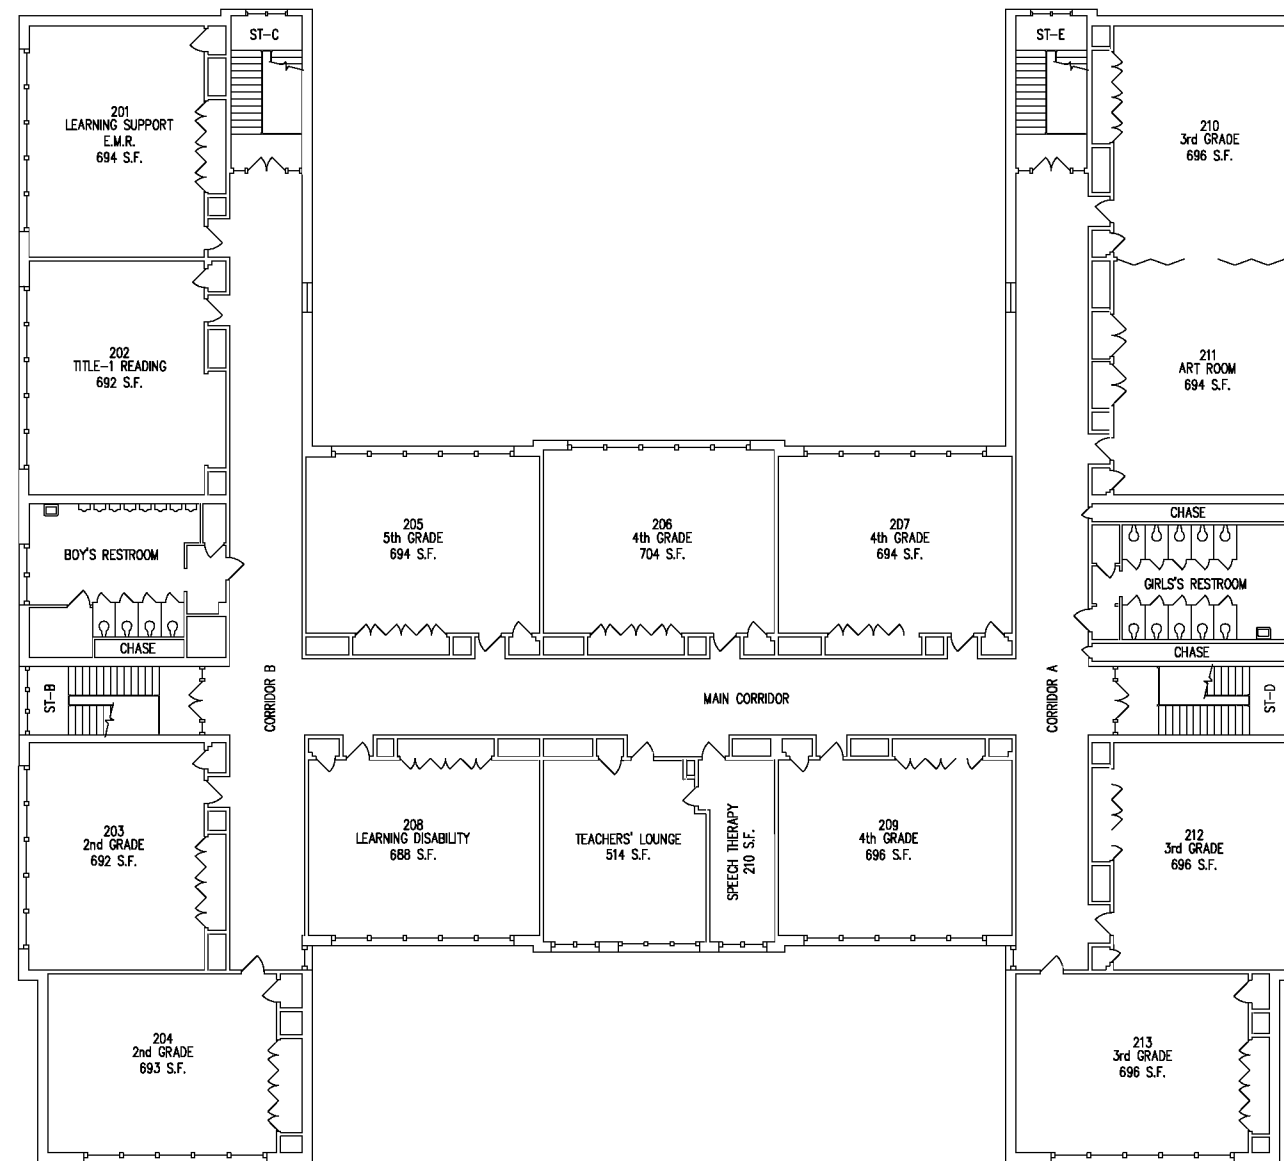
## 2ND FLOOR PLAN

ASSUMED ASBESTOS CONTAINING  
MISCELLANEOUS MATERIALS:

1. DUCTWORK FLEX CONNECTIONS
2. EXTERIOR DOOR CAULKING

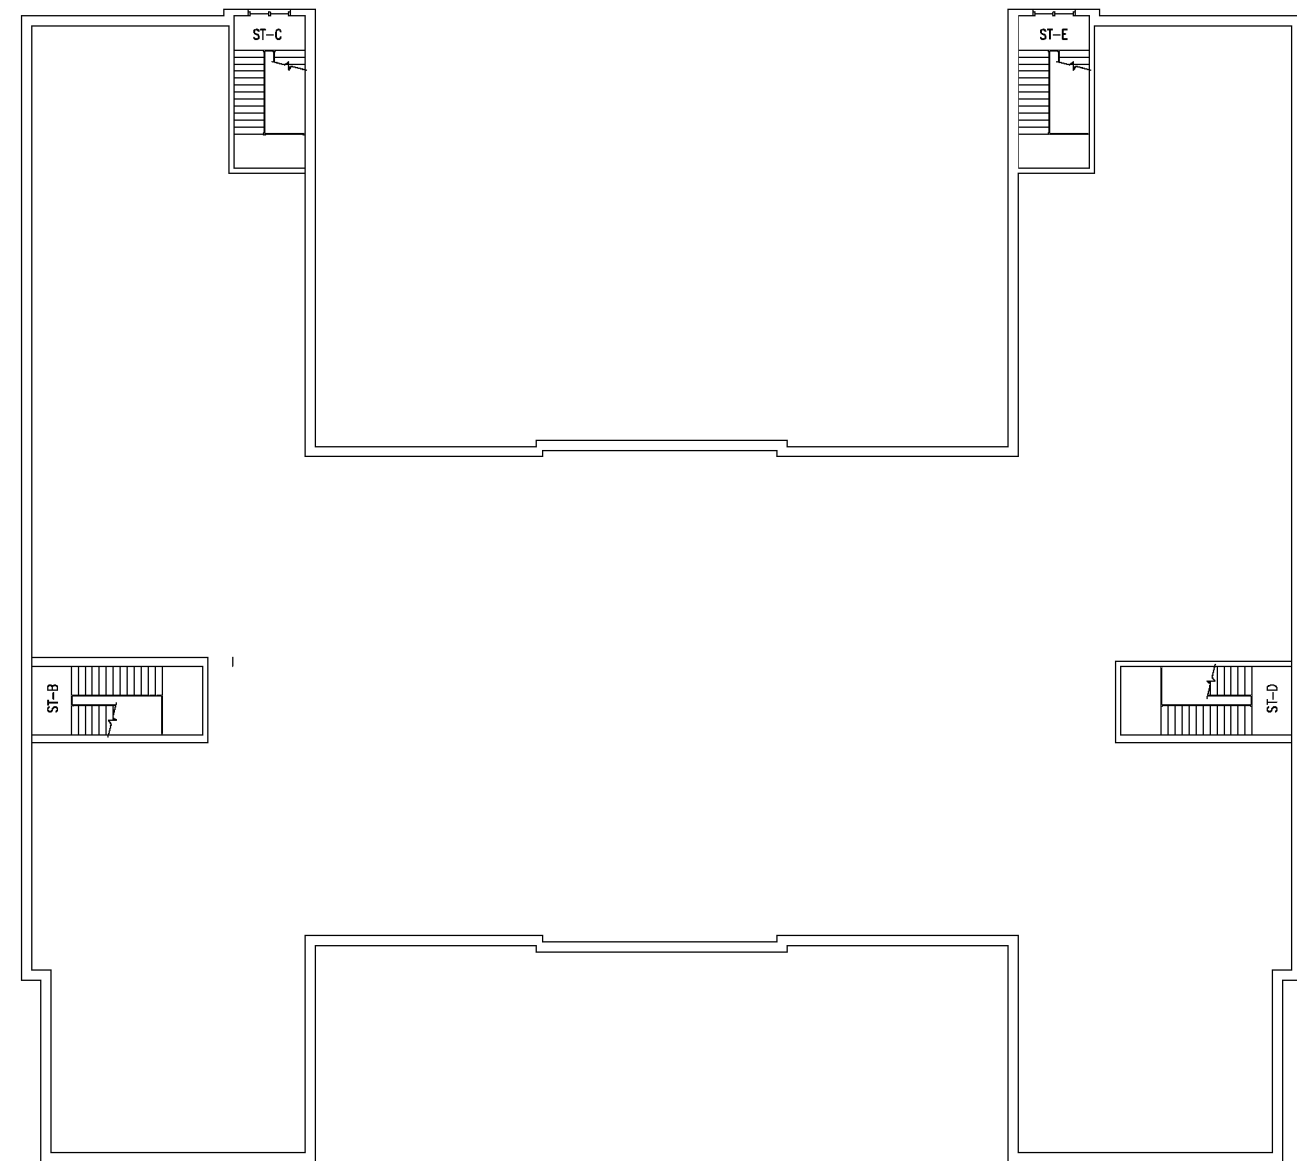
ATTIC PLAN  
NOT TO SCALE

ASSUMED ASBESTOS CONTAINING  
MISCELLANEOUS MATERIALS:

1. DUCTWORK FLEX CONNECTIONS
2. EXTERIOR DOOR CAULKING
